INSPECTION REPORT – COMMERCIAL PROPERTY

Location of Building Inspected: 120 W. North Avenue
Monticello, WI 53570

Date and Time of Inspection: December 17, 2015 @ 8:30 a.m.

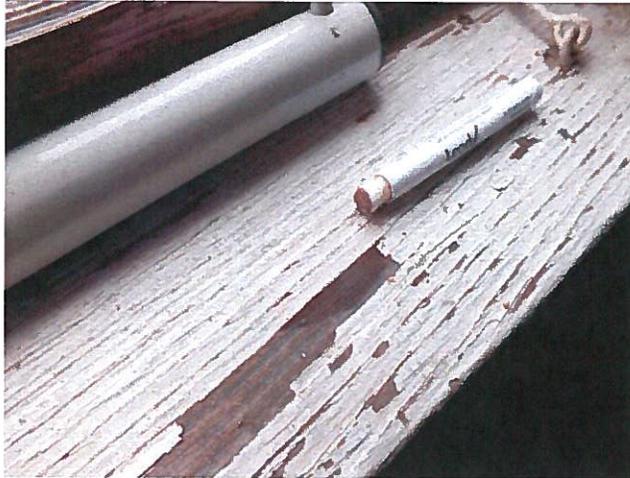
- Eight asbestos containing materials (ACM) samples were collected and tested. The pipe wrap in the northeast corner of the second level and the 9x9 floor tile on the second level were identified to be ACM and will need to be properly removed from the building if any remodeling work is performed. See the attached Exhibit A for the test results and Exhibit B for further information on ACM.
- Approximately eight lead based paint (LBP) tests were conducted and lead based paint was found on the second level window sashes. See the attached Exhibit C for further information on LBP.

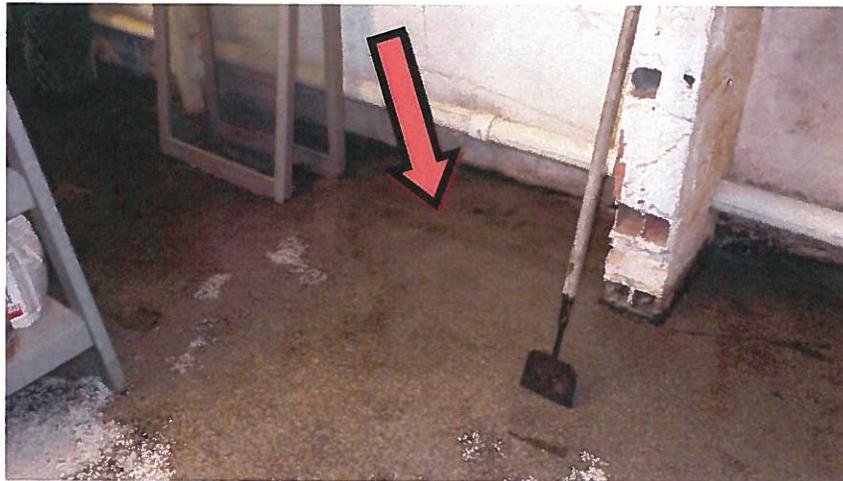
- Standing water was noted in the lower level. This is the cause of the high humidity levels in the lower level and the musky smell present in the building. It is also a potential source of mold and mildew growth. All cracks in the foundation walls need to be sealed and it is **recommended** that a Beaver Basement Water Control System (or similar) be installed. See the attached Exhibit D. This work, in conjunction with work outlined in the exterior and mechanical sections, could resolve approximately 75% of the moisture issues in the lower level.

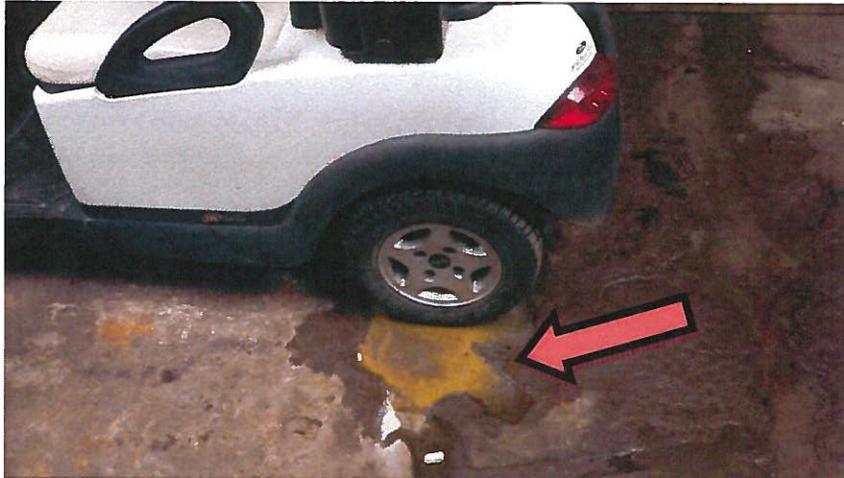
- The lower level needs to be thoroughly cleaned (1/2 cup bleach : 1 gallon water) to remove any mold or mildew that occurred as a result of the current moisture issues.
- There appears to be a small chemical spill in the south end of the lower level. This needs to be properly cleaned up.

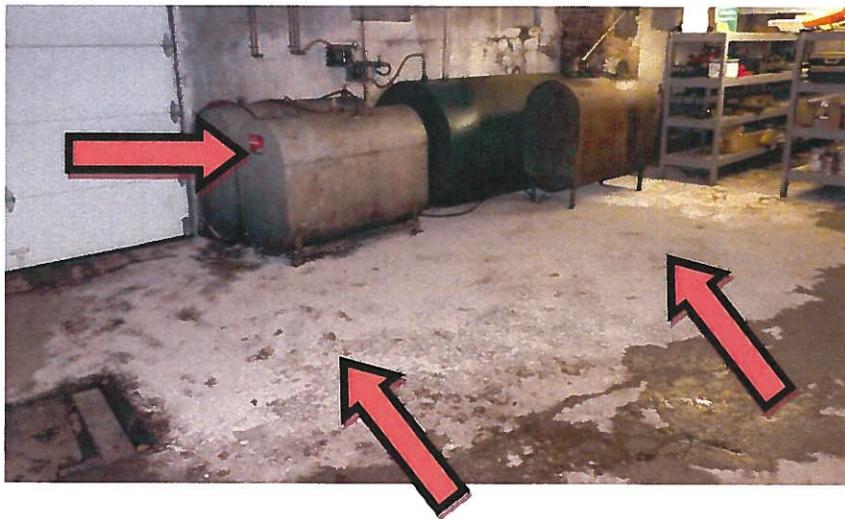
- An excessive amount of an "oil dry" product was spread on the floor of the lower level. The unused oil tanks need to be removed and this area needs to be properly cleaned.

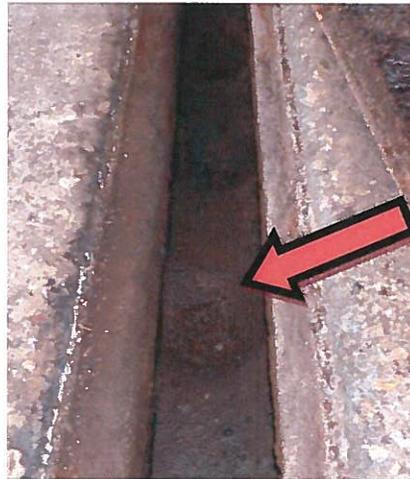
- There are multiple cracks in the concrete floor that need to be properly sealed.
- The trench drains and catch basins are full of sediment and need to be cleaned out.

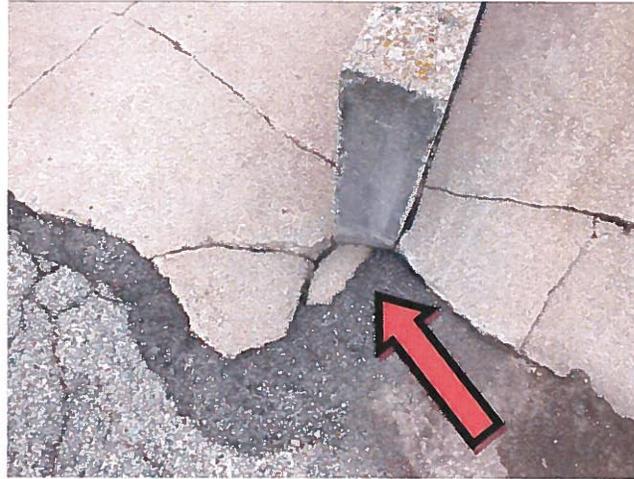
- ADA compliant entrances and fire exits need to be constructed. The current entrances to the building have steps and will need to be reconstructed with ramps.
- There are numerous areas where the slope of the grade allows stormwater to flow toward the building foundation. This includes two open voids under the concrete approach to the lower level overhead door. All grade (where applicable) should be corrected to provide a minimum of a 2% slope away from the building. All open voids,

gaps between the foundation and aprons, etc., where water may penetrate, should be filled and/or properly sealed.

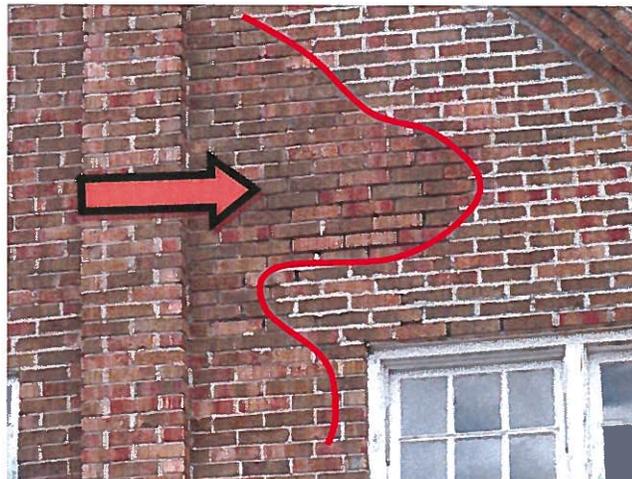
- Although previous work has been performed, tuckpointing will be required on a majority of the brick facade. This work is necessary to stabilize the brick facade and to keep water from penetrating. A small percentage of damaged brick (approximately 5%) will also need to be replaced during this work.

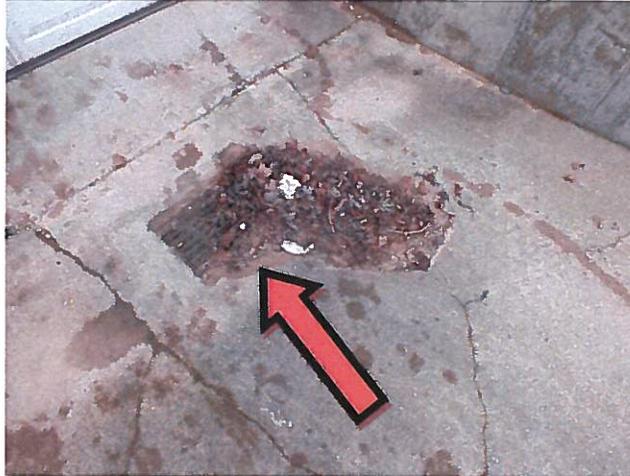
- The catch basin at the base of the ramp to the lower level overhead door is filled with debris and needs to be cleaned. Consideration should be given to installing a larger trench drain in this area to ensure that, during large rain events, no water is allowed into the building.

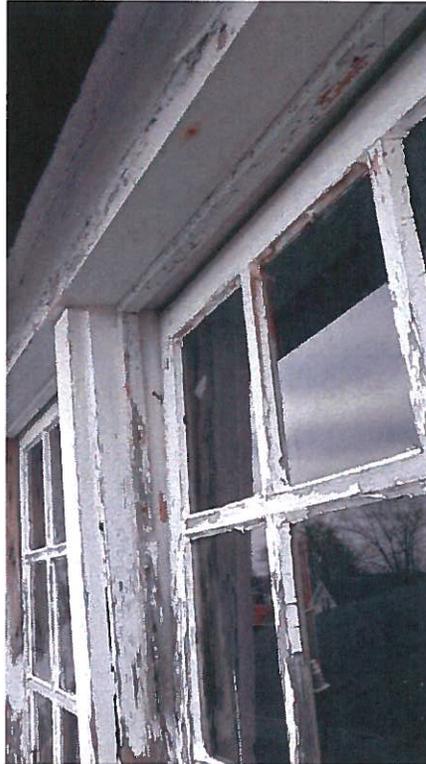
- The second level windows are in poor condition and need to be repaired or replaced immediately.

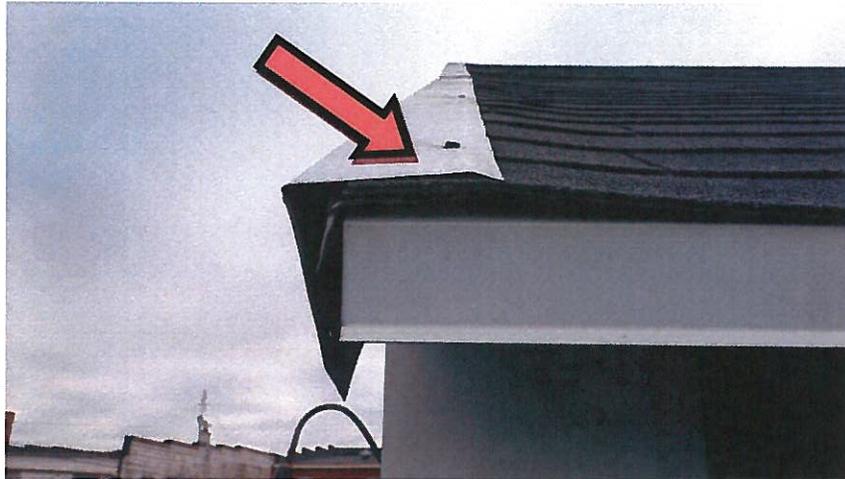
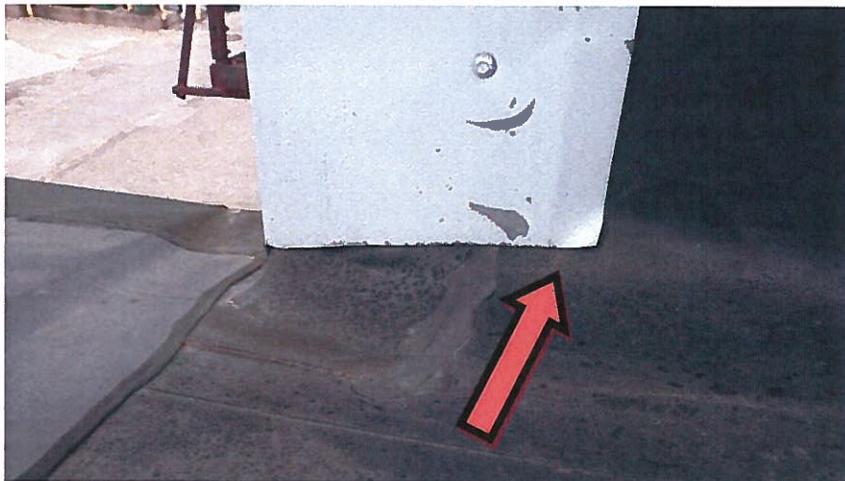
- There are several sections of flashing that are loose or improperly installed. This needs to be repaired.

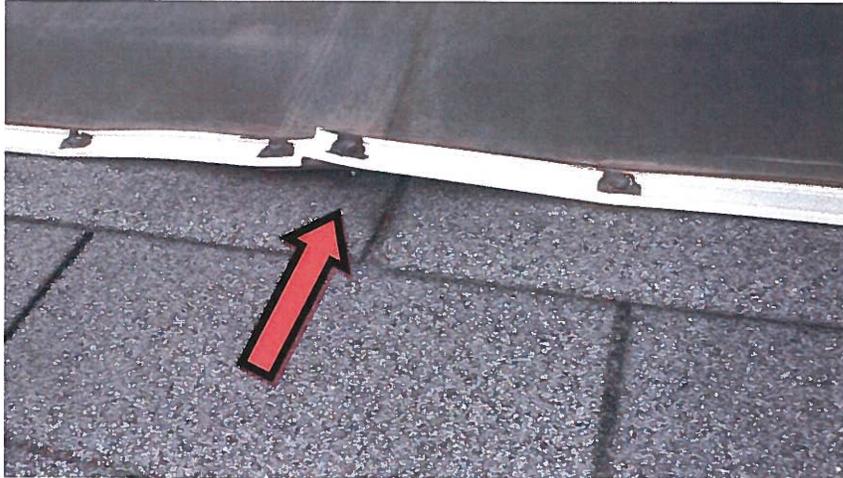
- There are several small sections of the EPDM termination strip that are loose and need to be refastened. All fasteners need to be re-caulked.

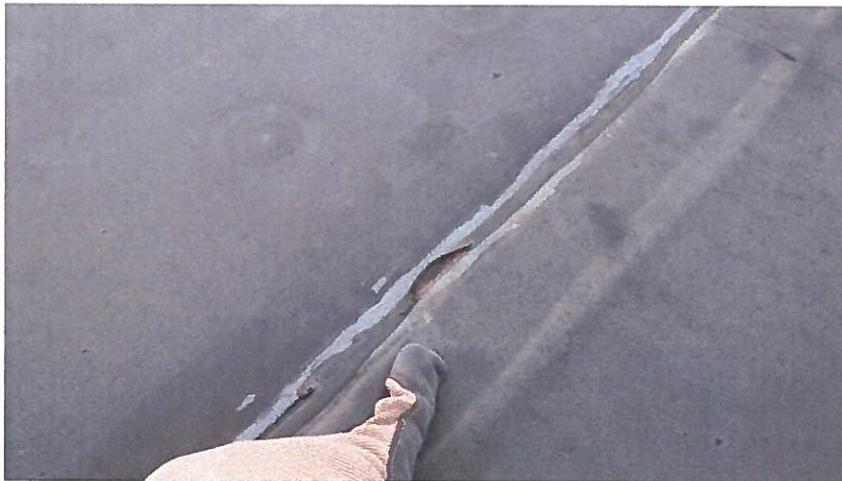
- The EPDM roof has several failed seams that need to be repaired immediately.

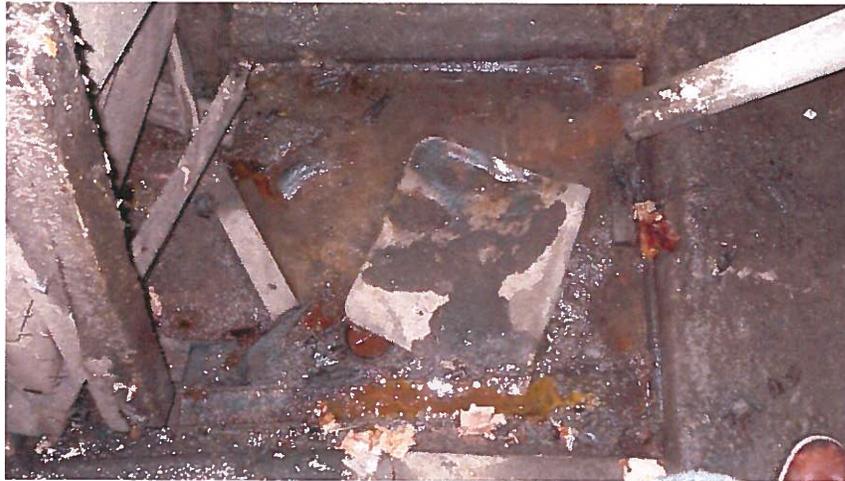
- Proper ventilation is needed for the entire building, including the lower level. Proper air movement and exchange will help to eliminate the moisture issues in the lower level and improve the air quality throughout the building.
- The existing open plumbing system in the lower level needs to be replaced with a properly vented closed system.

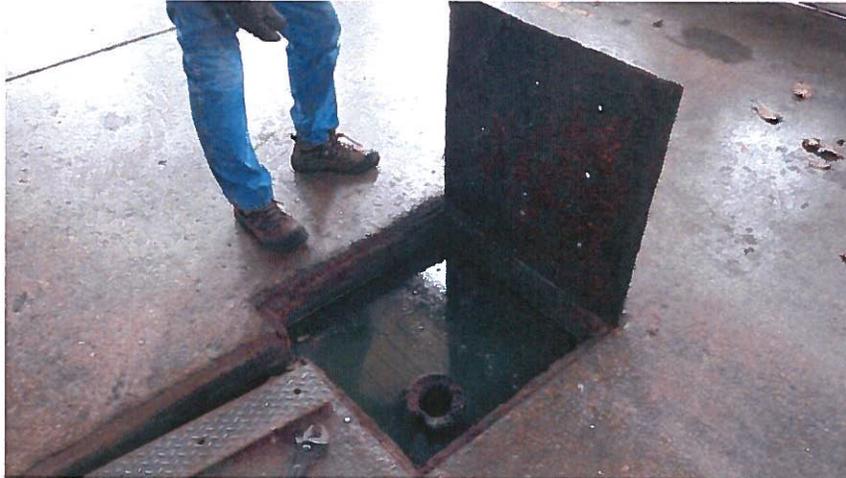
- The floor drains do not flow into an approved catch basin. The current catch basin does allow sediment to settle out; however, it does not prevent floating contaminants, such as oil, from getting into the plumbing system. An approved catch basin needs to be installed. See the attached Exhibit G for an example of an approved catch basin.

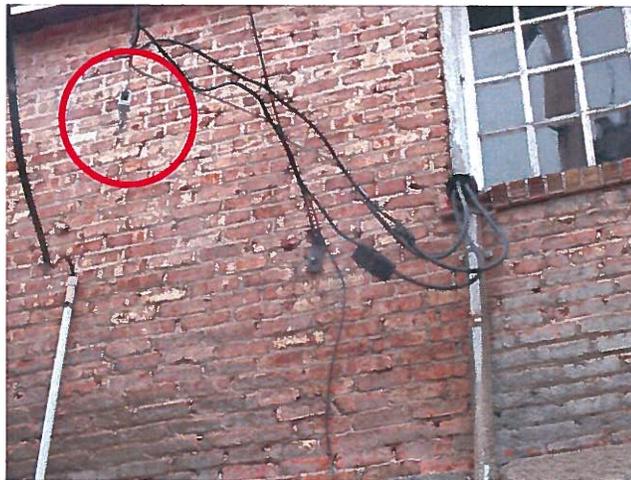
- The guide wire for the electrical service coming to the building has failed and needs to be repaired. There is currently excessive sag and tension on the energized wires.
